FRASER CITY COUNCIL – SPECIAL MEETING  
THURSDAY – JULY 18, 2019 @ 6:00PM  
AGENDA

Re: 15-Mile Repairs

The MCPWO directed AEW to draft a report summarizing the known history of the City of Fraser's 15 Mile Road water main. The following provides a chronology of projects and construction in the area of the water main leak.

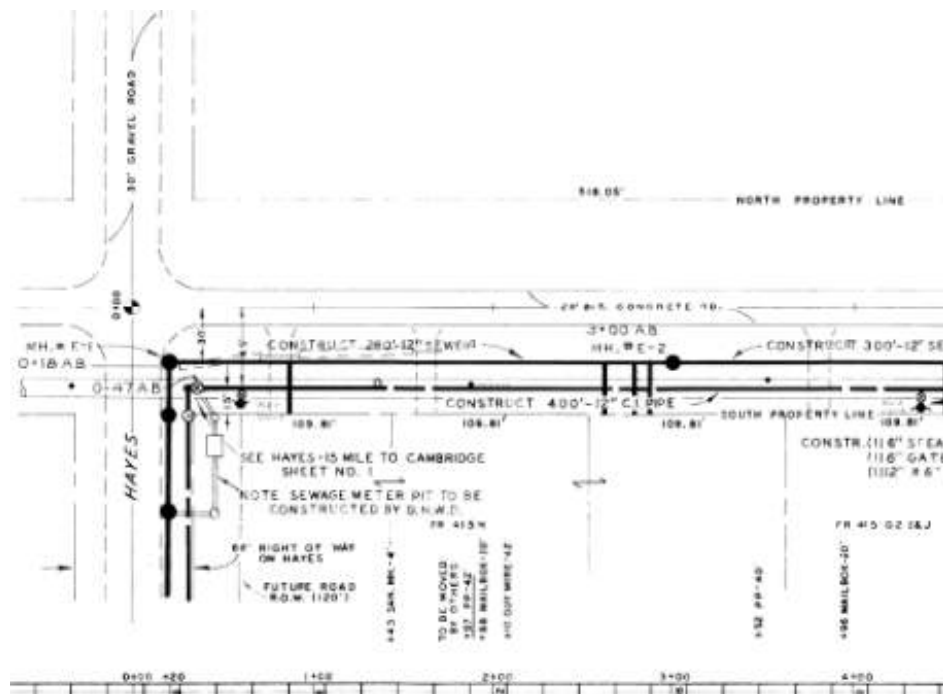
Figure 2.1-1 Original Construction Plan

The 15 Mile Road water main was approved as part of Special Assessment District S9 & W10 in 1969. 15 Mile Road was two lanes (20 ft wide) of bituminous pavement at the time of construction, estimated to be 1974. A 12" diameter C-76 Class IV reinforced concrete pipe sanitary sewer and a 12" diameter cast iron water main were constructed in the greenbelt south of 15 Mile Road. The sanitary sewer was constructed a consistent 30 feet south of the 15 Mile Road centerline and the water main was 45 feet south of the centerline. No horizontal bends or variance from these lines were noted.

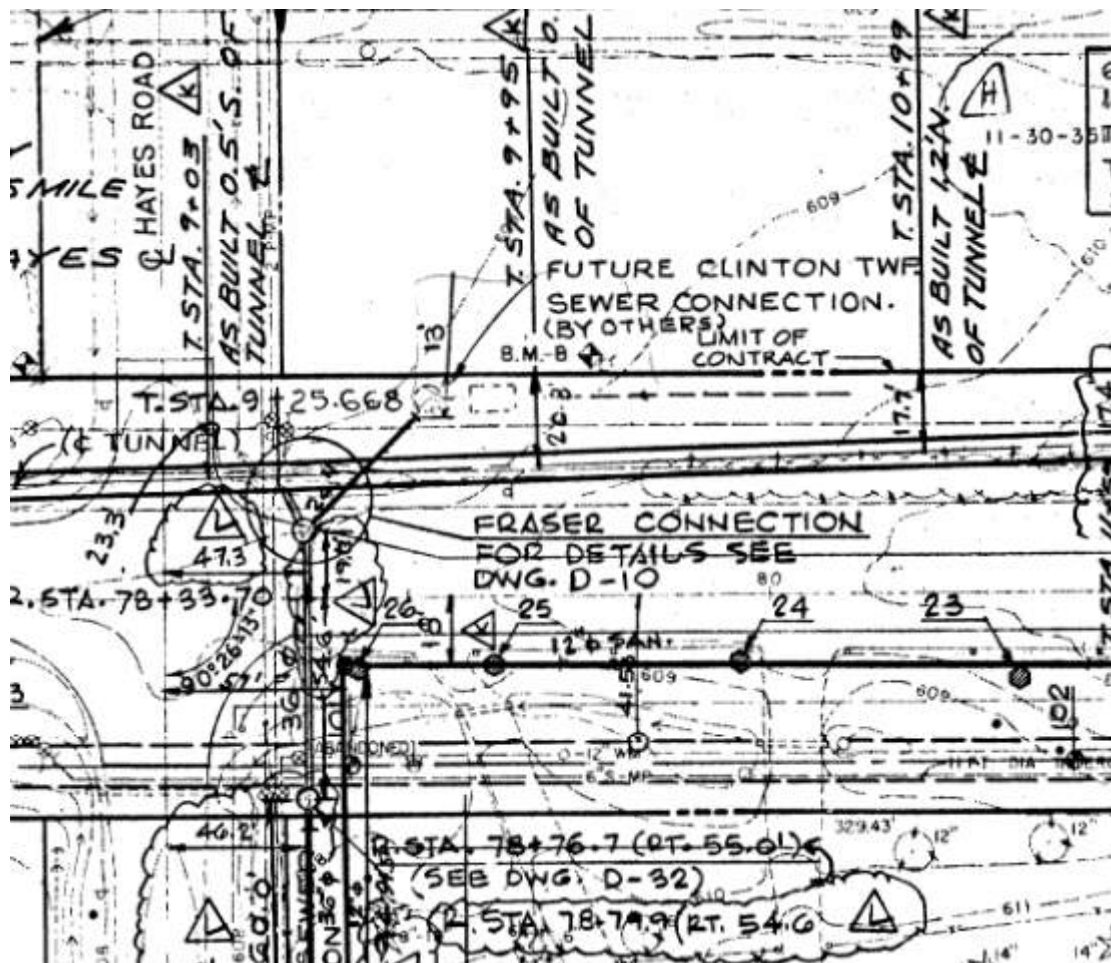
Figure 2.2-1 1978 Collapse – Water Main Abandonment

The 15 Mile Road 12" diameter water main was impacted by the 1978 collapse of the PCI-12A Interceptor at 15 Mile Road and Hayes Road. The Plan and Profile for construction of the 8 foot diameter repair tunnel show the 12" diameter water main was abandoned as part of the repair.

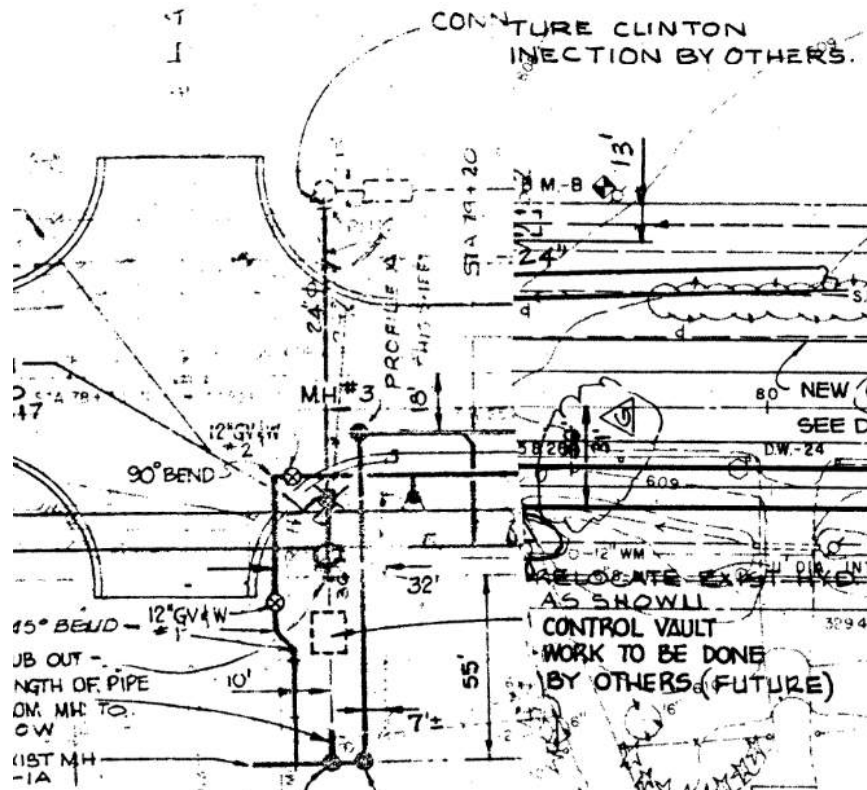
Figure 2.2-2 1978 Collapse – Water Main Repair Alignment

The alignment of the restored 12" diameter water main is unclear due to the available scan of the utility restoration work being poor quality, but it does indicate the new water main was 12" diameter ductile iron pipe. Applicable sheets from 1985 As-Built drawings of the 1978 collapse repair are included in Appendix B.

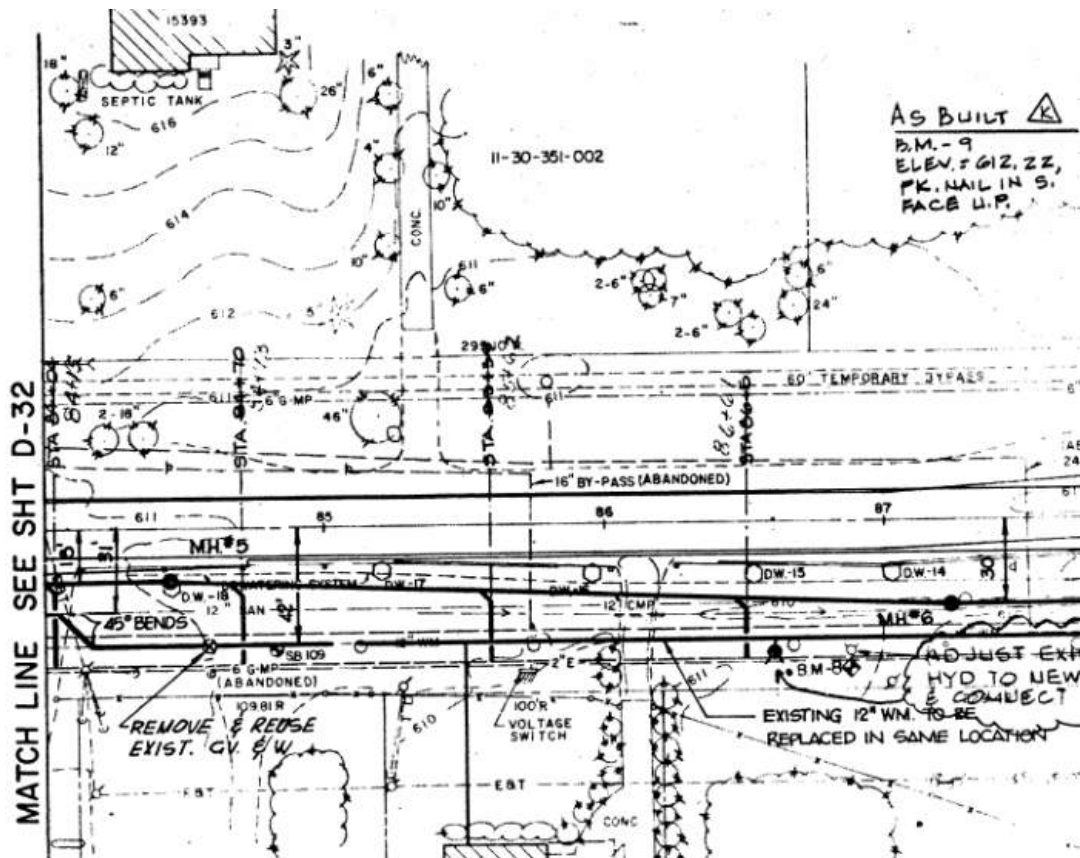
Figure 2.2-4 1978 Collapse – Waster Main Repair Alignment Shift

However, the restoration plans (Appendix B, Sheet D-33) indicate the alignment was shifted from the original alignment at the east limits, north approximately 15 feet, via 45-degree bends at the east property limit of 15370 15 Mile Road. This residence was condemned and demolished during the 2016 PCI-12A collapse repair and these bends, if accurate, would have been within the collapsed area and lost.

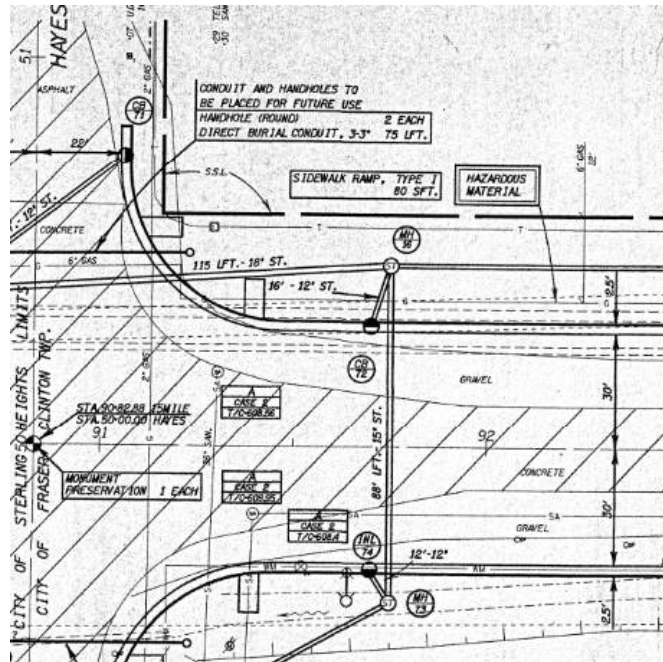
**Figure 2.3-1 1995 15 Mile Road Widening – Water Main Alignment at Hayes Road**

15 Mile Road was widened in 1995. No work to the 12" diameter water main was proposed as part of this construction, but utilities were shown on the plans. The 15 Mile Road 12" diameter water main was shown extending due east from the gate valve at Hayes Road beneath the new southerly curb and gutter. The water main is now shown as 30 feet south of the 15 Mile Road centerline. Note this is 15 feet north of the original 1974 construction plans. No statement was made as to the material.

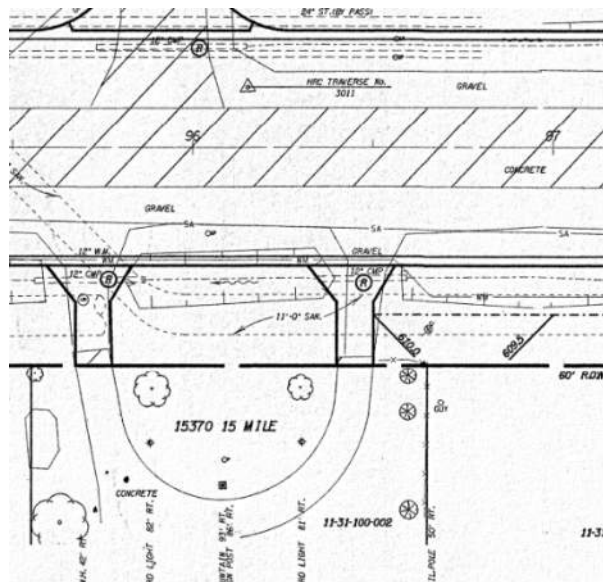
**Figure 2.3-2 1995 15 Mile Road Widening – Alignment Shift at 15370 15 Mile Road**

These 1995 plans also show the 15 Mile Road water main shifting to the north via 45-degree bends, as shown in the 1978 Repair plans (Appendix C, Sheet 19). Again, this residence was condemned and demolished during the 2016 PCI-12A collapse repair and these bends would have been within the collapsed area and lost.

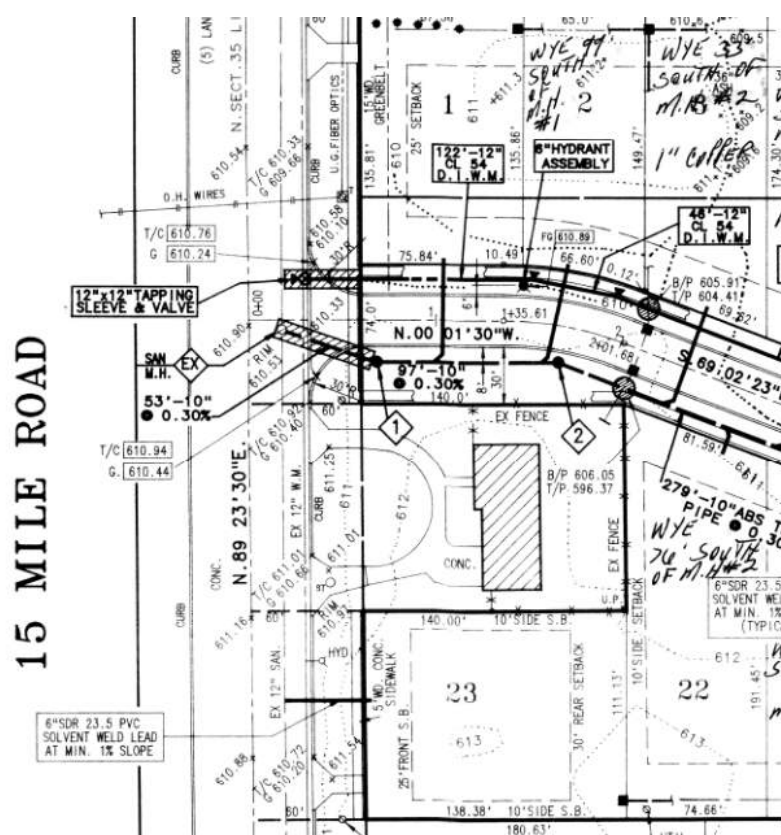
Figure 2.4-1 1997 Whispering Pines Subdivision

In December 1996 engineering plans were approved for construction of Whispering Pines Subdivision. Development of this site resulted in construction of Eberlein Drive, including a 12" diameter ductile iron water main on Eberlein Drive that connected to the 15 Mile Road 12" diameter water main. The 15 Mile Road water main is shown under the curb and gutter, which conflicts with the alignment shift shown in the 1978 PCI-12A Repair and 1995 15 Mile Road widening plans. Applicable sheets from the Whispering Pines drawings are included in Appendix D.

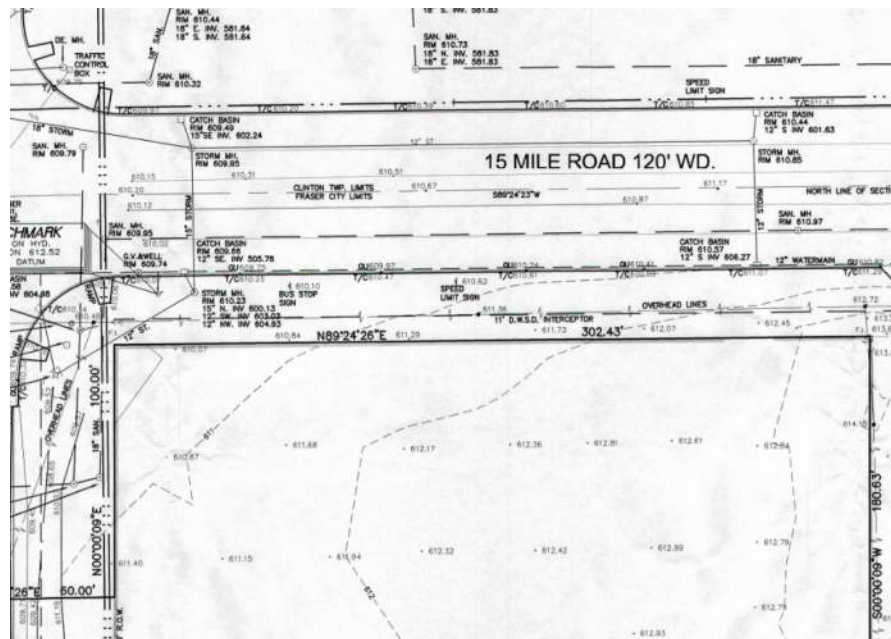
Figure 2.5-1 2003 15 Mile & Hayes Retail Center – Alignment at Hayes Road

In June 2003 engineering plans were approved for construction of a retail center at the southeast corner of 15 Mile Road and Hayes Road. This retail center became home to the engineering office during repair of the 2016 PCI-12A collapse. No work was proposed to the 15 Mile Road water main, but the plans showed a 12" diameter water main under the curb and gutter. Water service to the retail center was made by tapping the 12"

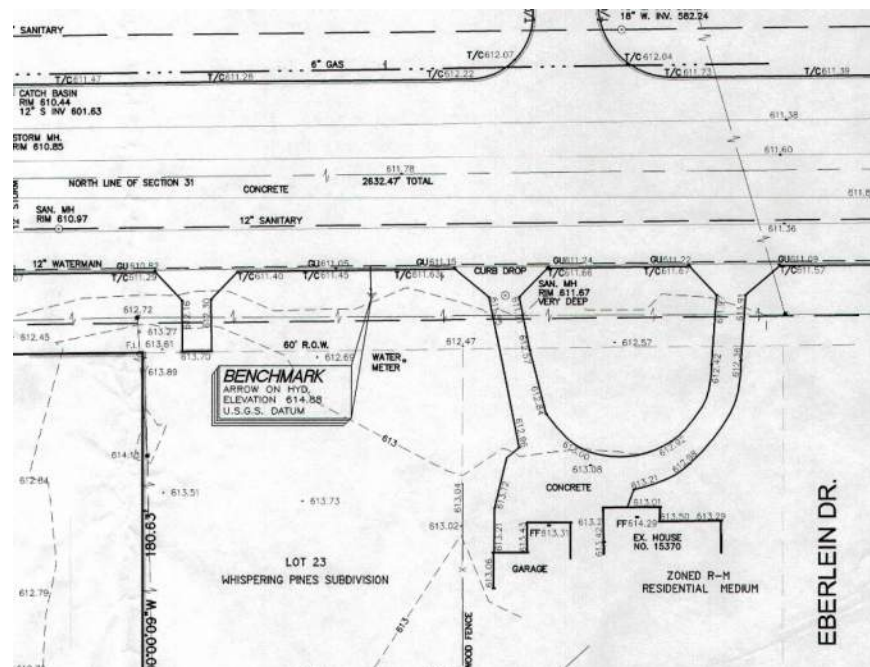
Figure 2.5-2 2003 15 Mile & Hayes Retail Center – Alignment at Eberlein Drive

Similar to Whispering Pines Subdivision, these plans do not show the alignment shift at the east property limit of 15370 15 Mile Road.

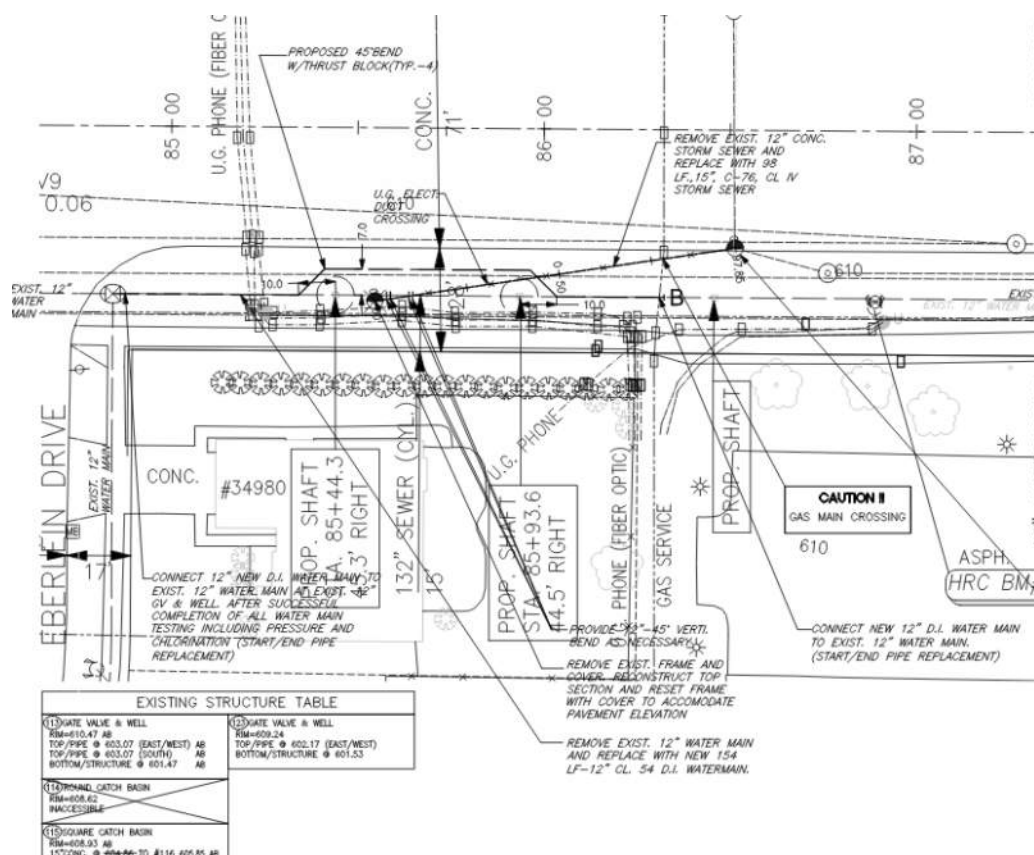
Figure 2.6-1 2004 Collapse – Water Main Repair

The 15 Mile Road 12" diameter water main was again impacted by the 2004 collapse of the PCI-12A Interceptor along 15 Mile Road just west of Hayes Road. Two shafts were constructed just east of Eberlein Drive as part of the bypass pumping effort. The Utility Restoration Plan shows the 15 Mile Road 12" diameter water main was replaced from the gate valve at Eberlein Drive to approximately the property line between 34980 Eberlein and the Fraser Senior Center. The alignment is within the greenbelt and a portion was deflected 7 feet north to go around the bypass pumping shafts, which remained as permanent structures. Applicable sheets from the record plan are included in Appendix F.

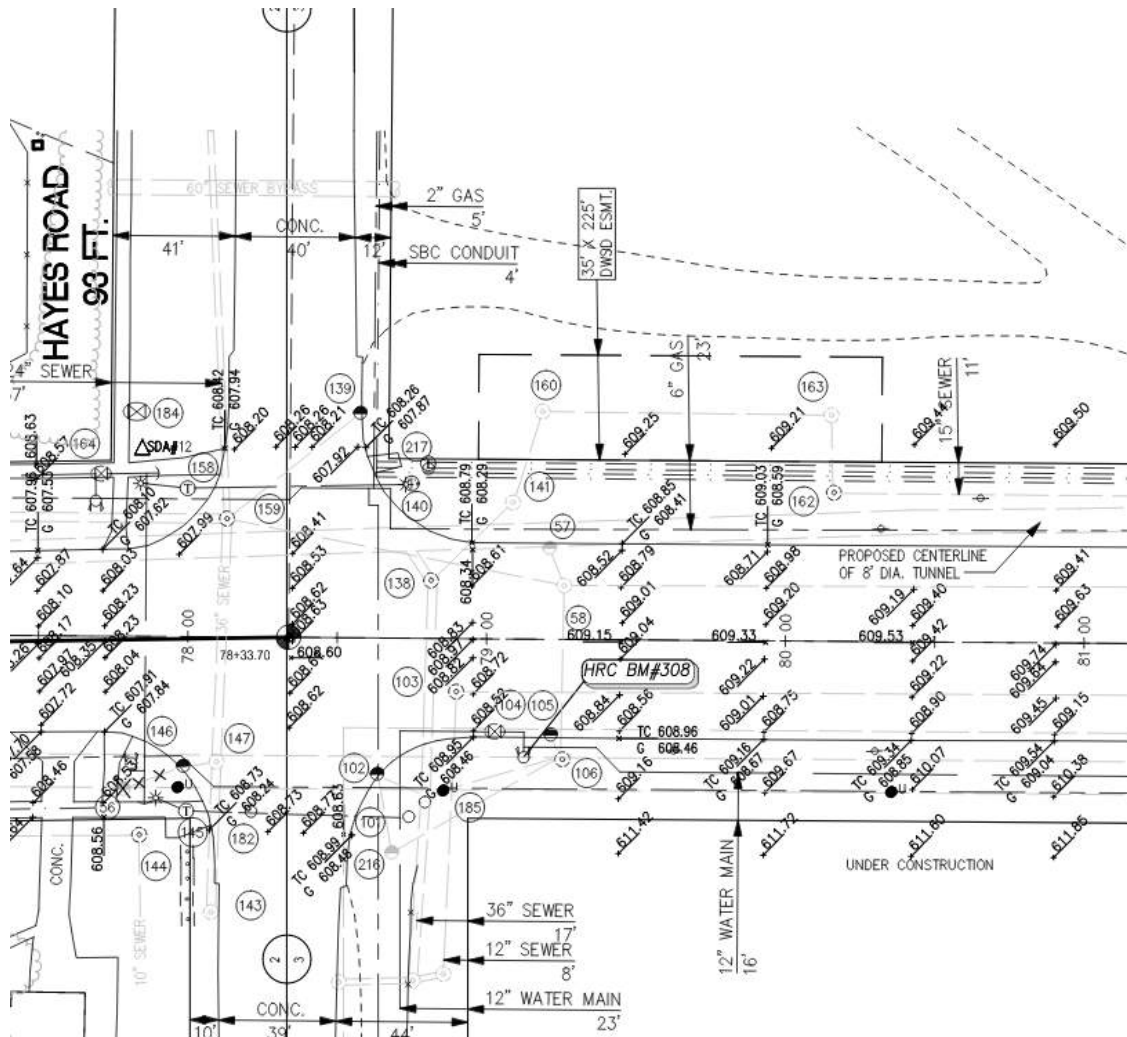
Figure 2.6-2 2004 Collapse – Water Main Alignment at Hayes Road

Additionally, the topographical survey from repair of the 2004 PCI-12A collapse shows the 12" diameter water main shift from beneath the curb and gutter to the greenbelt immediately east of the gate valve at 15 Mile Road and Hayes Road.

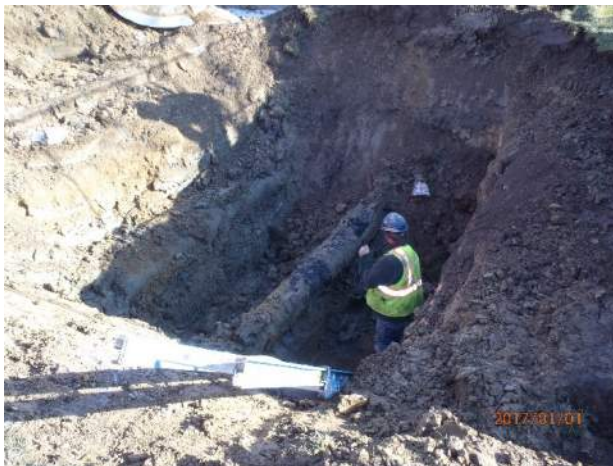
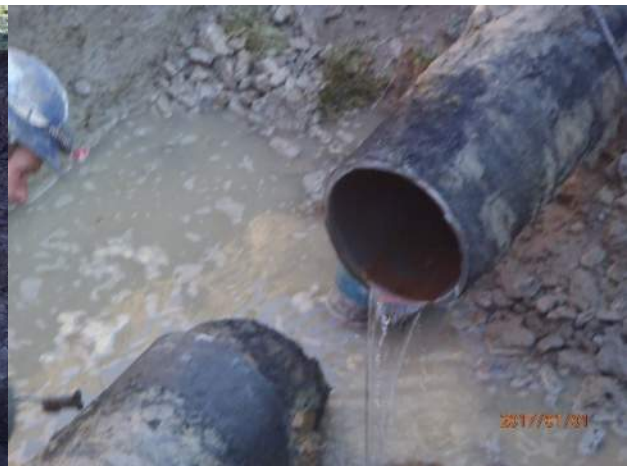
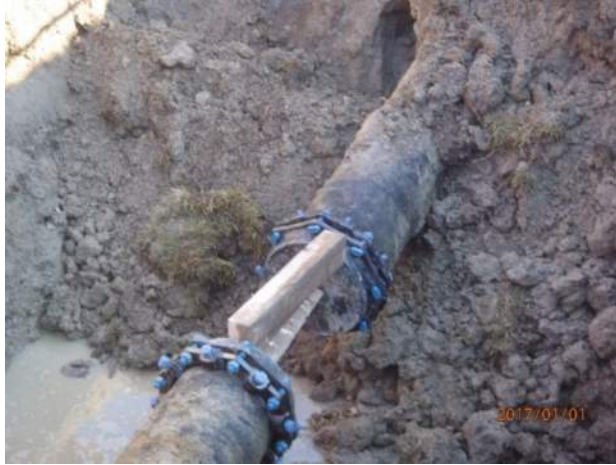
On January 1<sup>st</sup>, 2017, a two (2) foot section was cut out of the 12" diameter ductile iron water main on 15 Mile Road. Both ends of the 12" diameter water main were capped with bolted caps fastened to retainer glands. 4" by 4" timbers were wedged between the caps to act as thrust restraint. The location was marked with a 2"x4" painted blue.

**Figure 3.1-1 2016 Collapse – East of Sinkhole**

**Figure 3.1-2 2016 Collapse – 2 Ft Section Cut**

**Figure 3.1-3 2016 Collapse – Both Ends Capped**

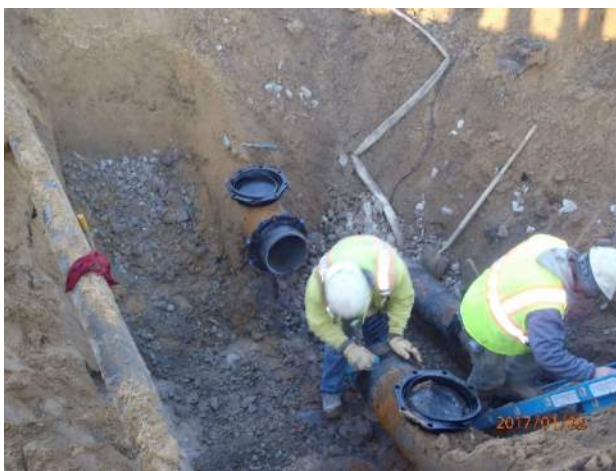
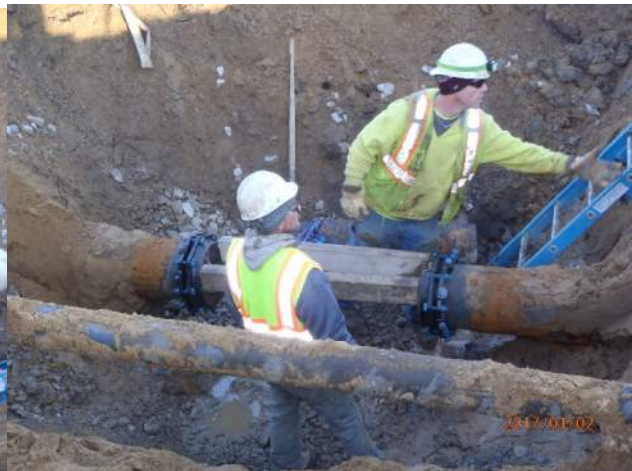
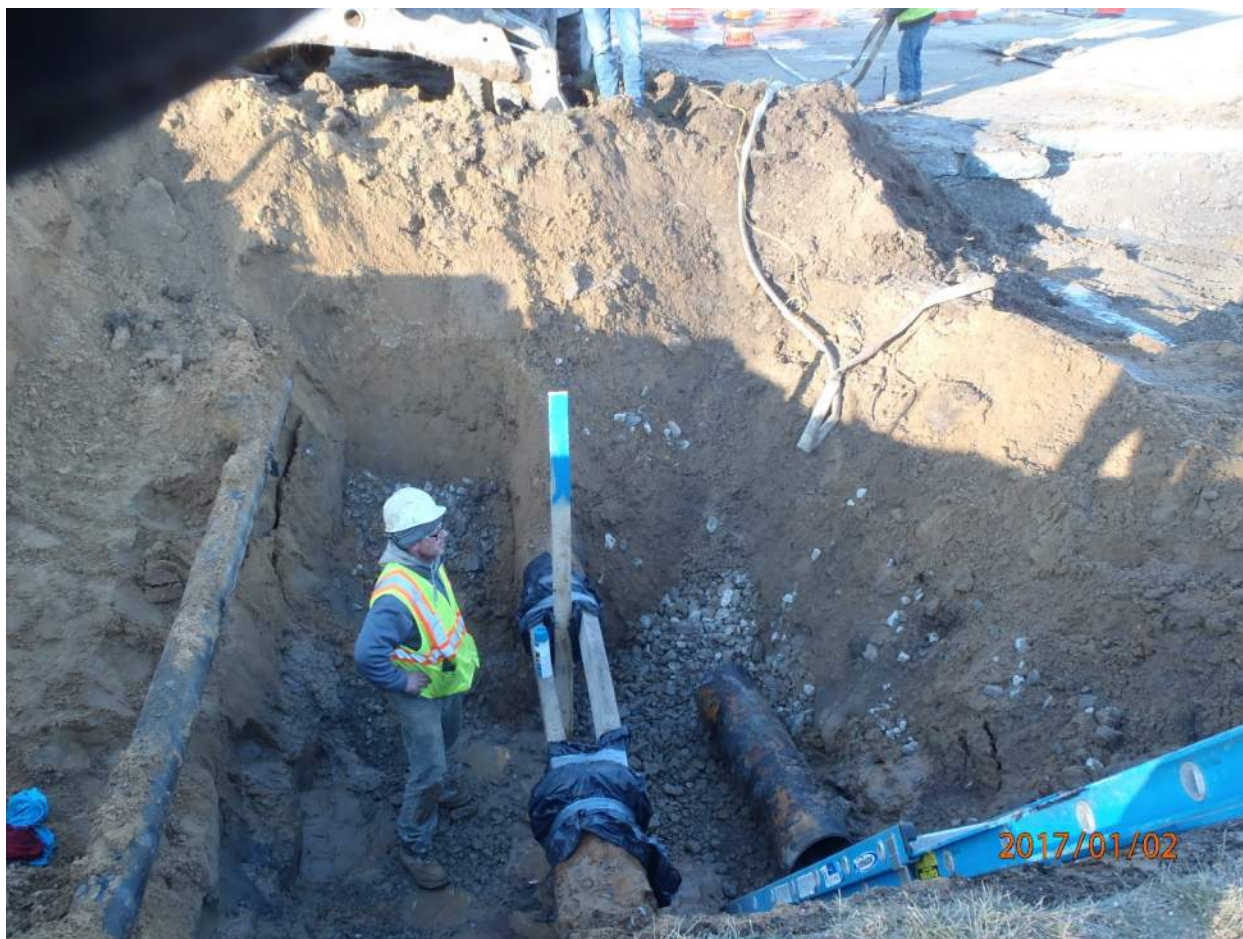
On January 2<sup>nd</sup>, 2017, an approximately three (3) foot section was cut out of the 12" diameter ductile iron water main on 15 Mile Road. Both ends of the 12" diameter water main were capped with bolted caps fastened to retainer glands. 4" by 4" timbers were wedged between the caps to act as thrust restraint. The location was marked with a 2"x4" painted blue.

**Figure 3.1-4 2016 Collapse – West of Sinkhole**

**Figure 3.1-5 2016 Collapse – Both Ends Capped**

**Figure 3.1-6 2016 Collapse – Location Stake**

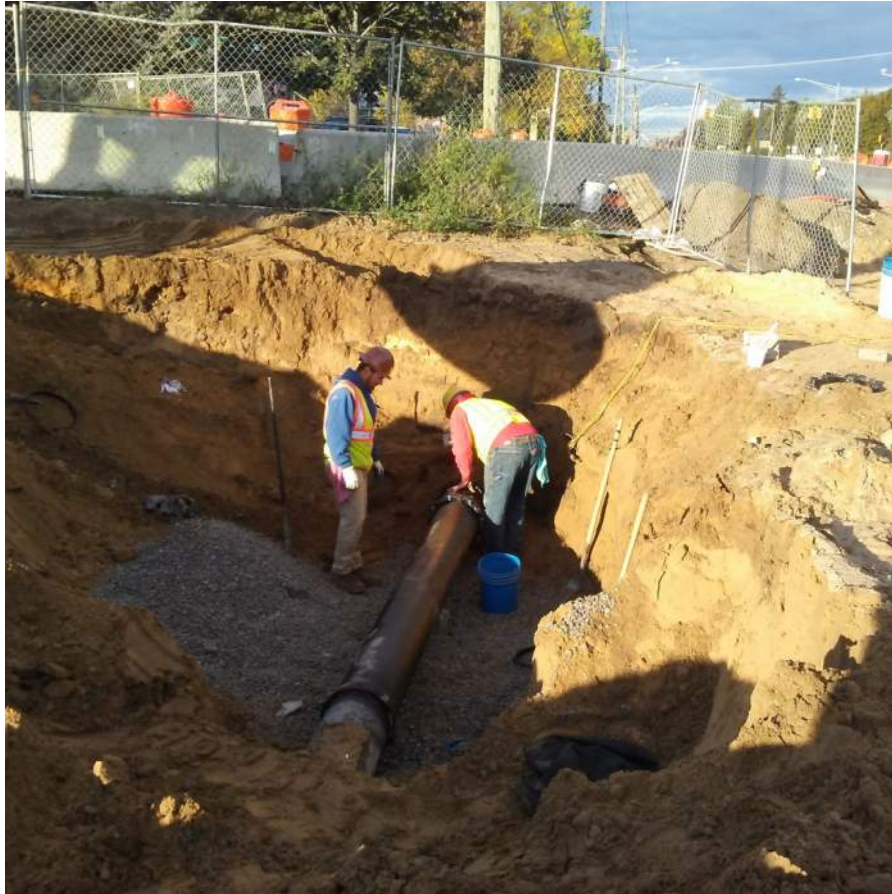
**Figure 3.2-1 2016 Collapse – Final Water Main Connection West of the Collapse**

Subsequent to repair and restoration of flow through the interceptor, the site was backfilled and the utilities restored. New 12" diameter ductile iron water main was installed on October 10, 2017. A total of 525 feet of new pipe, one 12" diameter gate valve and well, and two hydrants were installed. Caps and blow offs were installed at the east, west and south limits near the capped ends installed and surveyed during the emergency

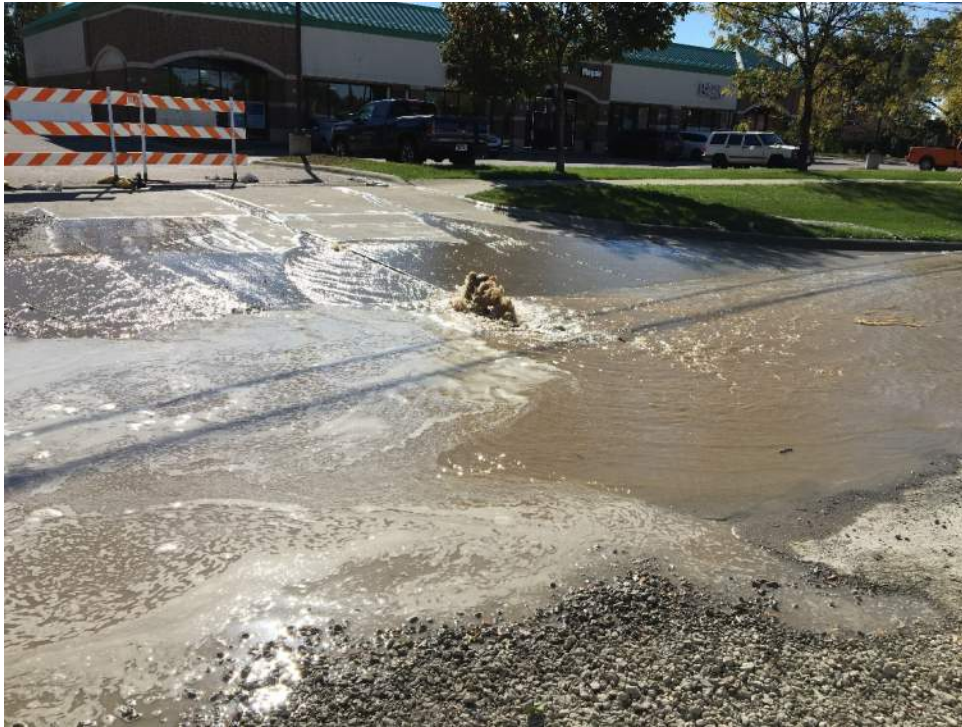
**Figure 3.2-2 2016 Collapse – Water Main Break October 16, 2017**

Upon completion of the final water main connections, the new main was brought into service by opening the gate valves on Hidden Pine south of 15 Mile Road and 15 Mile Road east of Hidden Pine. The new gate valve on Eberlein Drive, just south of 15 Mile Road, and the existing gate valve on 15 Mile Road at Hayes Road were still closed. Water was immediately observed surfacing at the drive approach to the 15260 15 Mile Road storefront. It was assumed to be a break in the existing water main that had been capped

and isolated for over 10 months. This apparent break was approximately 100 feet west of the new water main connection.

The City of Fraser was immediately notified and the gate valves at 15 Mile Road and Hidden Pine were closed again. The Fraser DPW and Miss Dig responded to the site. It was mutually determined the City of Fraser could not make repairs at this time without closing the temporary access road to Eberlein Drive. All parties agreed Dan's Excavating would repair the break under a Field Order, coordinated with planned traffic shifts and removal of the temporary sanitary sewer, so as to not impact the schedule for reopening 15 Mile Road. Applicable daily reports and photographs are included in Appendix G.

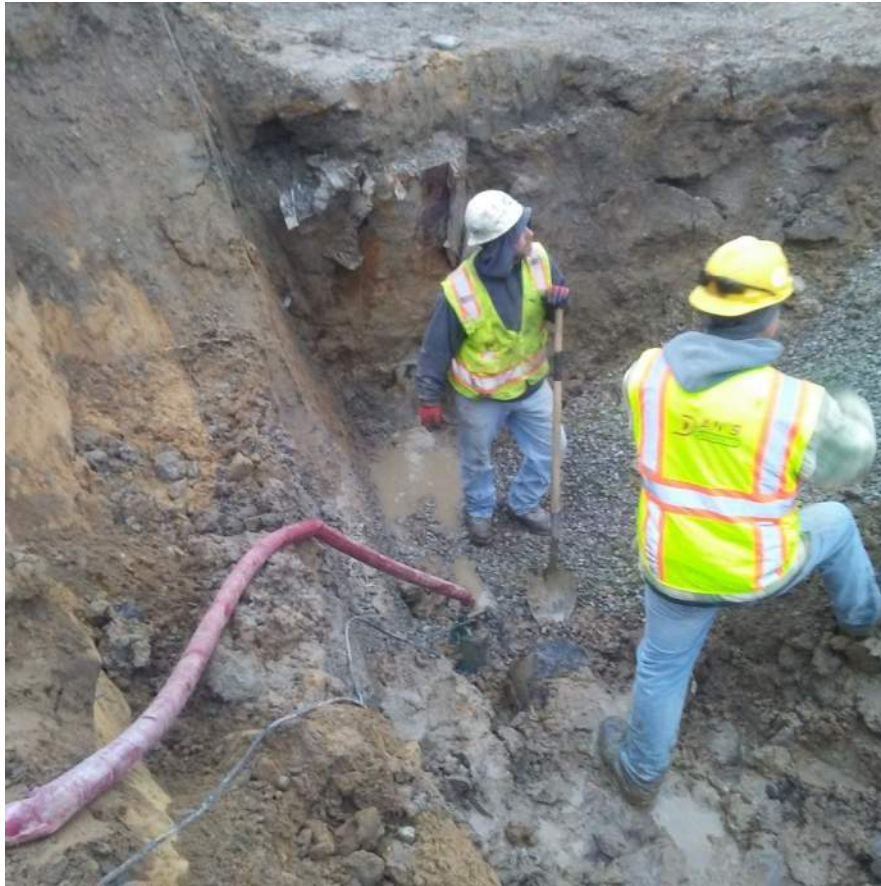
**Figure 3.2-3 2016 Collapse – Existing Water Main Open Pipe**

On November 13<sup>th</sup> the south two lanes of 15 Mile Road had been poured and Eberlein access had been shifted to the east. This permitted Dan's Excavating to proceed with utility restoration work adjacent to the water main break from October 16<sup>th</sup>. Upon excavation it was discovered the existing pipe was not connected to the gate valve at

Hayes Road. It was interrupted by a buried casing and each end of the water main was open.

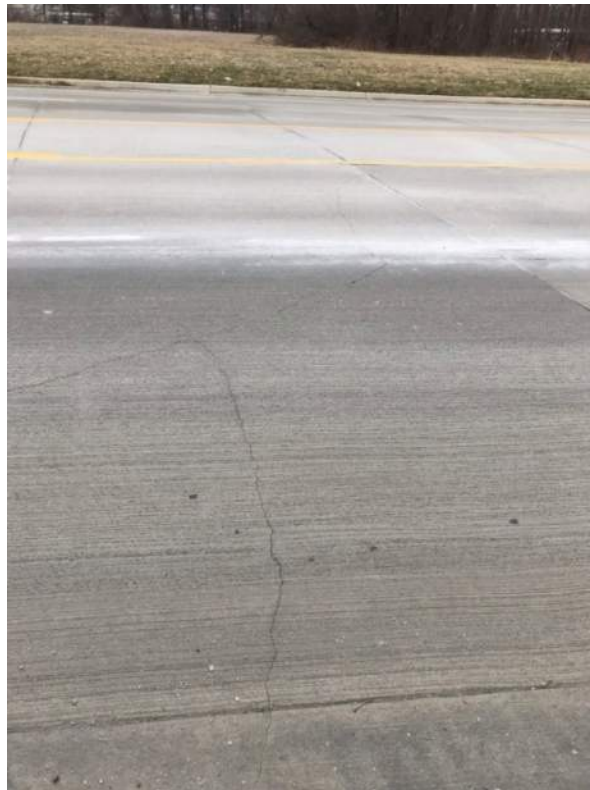
**Figure 4.0-1 2019 Break – Pavement Cracking Across 15 Mile Road**

An apparent water main leak on January 15, 2019 resulted cracking across all five lanes of 15 Mile Road. Subsequent freeze thaw cycling revealed a void beneath the pavement and closure of the eastbound curb lane on February 6, 2019. Temporary repairs were made February 6<sup>th</sup> – 8<sup>th</sup> and the eastbound curb lane was reopened to traffic the morning of February 11<sup>th</sup>.

Energizing the water main resulted in a leak east of the 15260 15 Mile Road Storefront office approach that elevated the pavement in 15 Mile Road, cracking pavement across five (5) lanes. The water main had reportedly been in service for more than 12 hours before the effects of the leak were apparent. A site visit by MCPWO, MDoR and AEW representatives concluded the pavement was elevated, but did not represent a safety risk to the public. The saturation of the sand backfill, coupled with freezing temperatures, resulted in frost under the pavement. All parties agreed to return after the thaw to reassess the condition of the pavement and further investigate the potential location of the 12" diameter water main running east from Hayes Road.

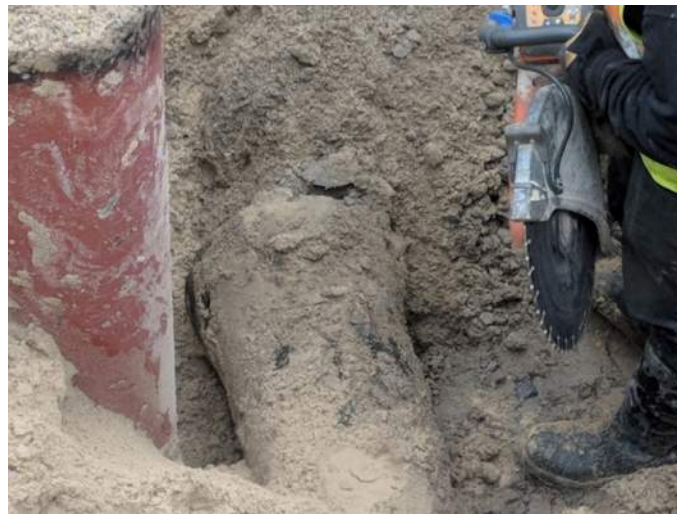
**Figure 4.0-2 2019 Break – Termination of Water Main**

The exploratory excavation revealed a 12" diameter ductile iron water main beneath the curb and gutter. The water main break was determined to be a failed masonry bulkhead installed sometime prior to the PCI-12A collapse. This water main was connected to the Hayes Road gate valve and terminated at this location prior to 2016.

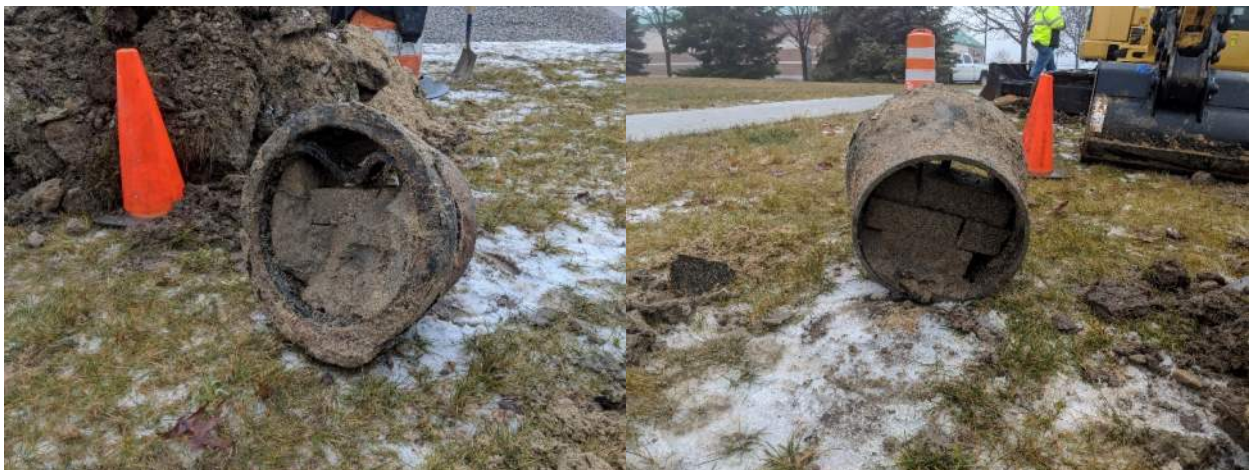
**Figure 4.0-3 2019 Break – Bulkhead**

**Figure 4.0-4 2019 Break – Bulkhead**

From the report you will see that the water main along 15 Mile road was stubbed from either direction. The City of Fraser was unaware of the stubbed water main and subsequently unaware of the inferior masonry bulkhead. DWSD owned the interceptor sewer and was responsible for the repairs made during the 1978 and 2004 collapses that affected the utilities in 15 Mile Road. The inferior water main work was not performed as part of the 2016-2017 collapse repair and subsequently (in my opinion) is not the responsibility of the MIDDD, MCPWO or the City of Fraser.

The field investigation/exploratory excavation revealed that the water main leak occurred at the masonry bulkhead.

A portion of the pipe including the masonry bulkhead was cut and removed during exploratory excavation and a retainer gland and bolted cap were installed. The excavation was backfilled with sand and a temporary concrete patch was poured on February 8, 2019. 15 Mile Road was completely reopened to traffic the morning of February 11, 2019. A map showing the location of the leak, photographs and daily reports are included in Appendix H.
